PROJECT: Midnite Mine Remediation

REPORT NO: 2019-007

MIDNITE MINE HEALTH & SAFETY SUMMARY: Reporting Period May 10 – 16, 2019

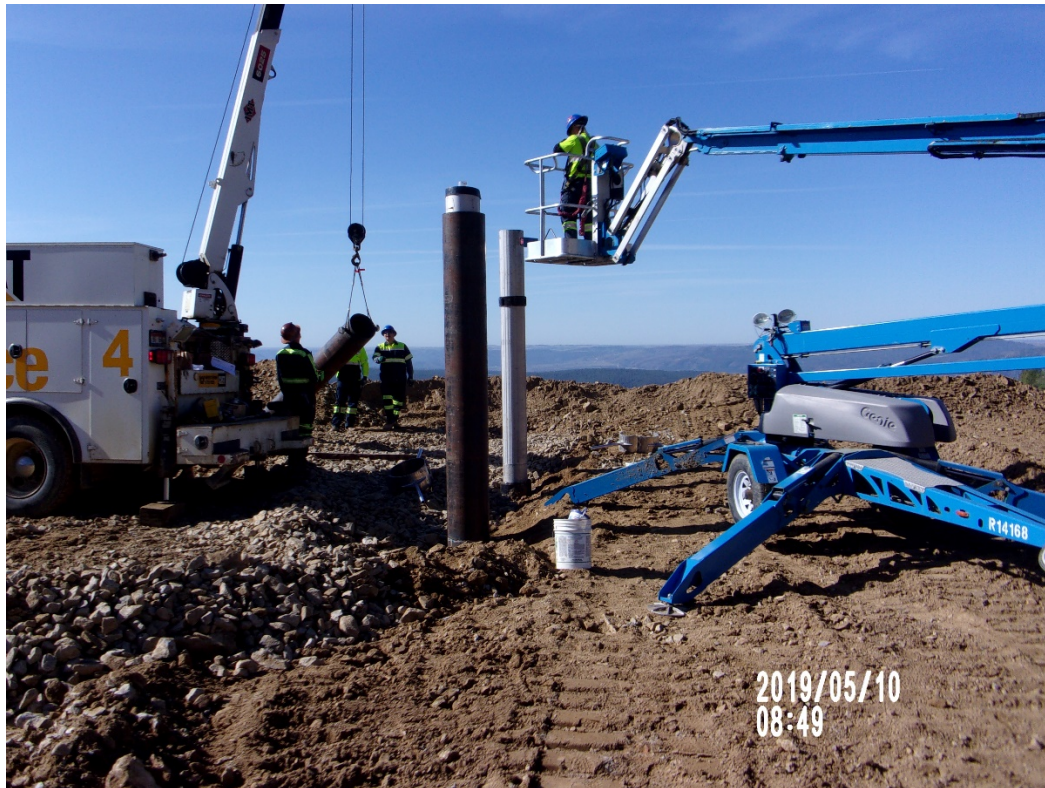
Figure 1 – Western States lifting carbon steel friction sleeve to place over the stainless-steel riser pipe.

- WRDS/UDS Risers
 - Another set of risers and friction sleeves were installed on 5/10/2019.
 - UDS risers are at a total depth of 230 feet.
 - WRDS risers are at a total depth of 190 feet.

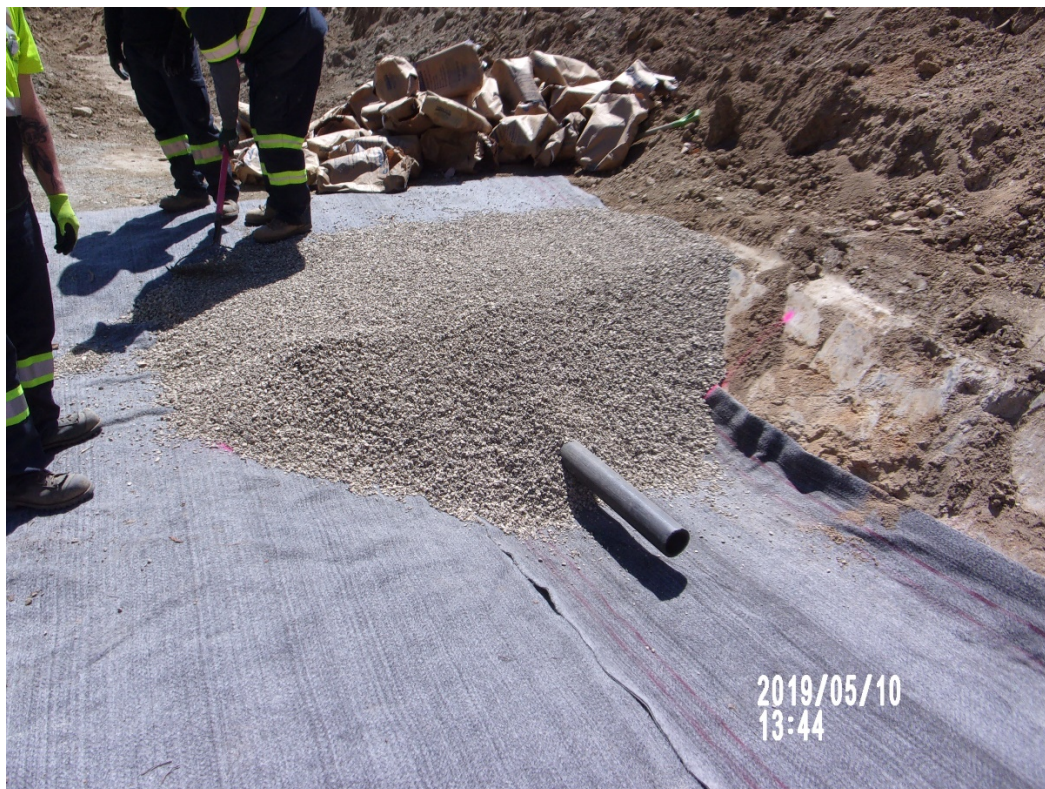
Figure 2 – Bentonite plug installed over GCL on the West Infiltration Collector.

- Began placing Geocomposite Clay Liner (GCL) and Drain Gravel in the west Infiltration Collection system on May 10. The bentonite plug at the transition from the gravel-lined collection to the pipeline was installed on May 10.

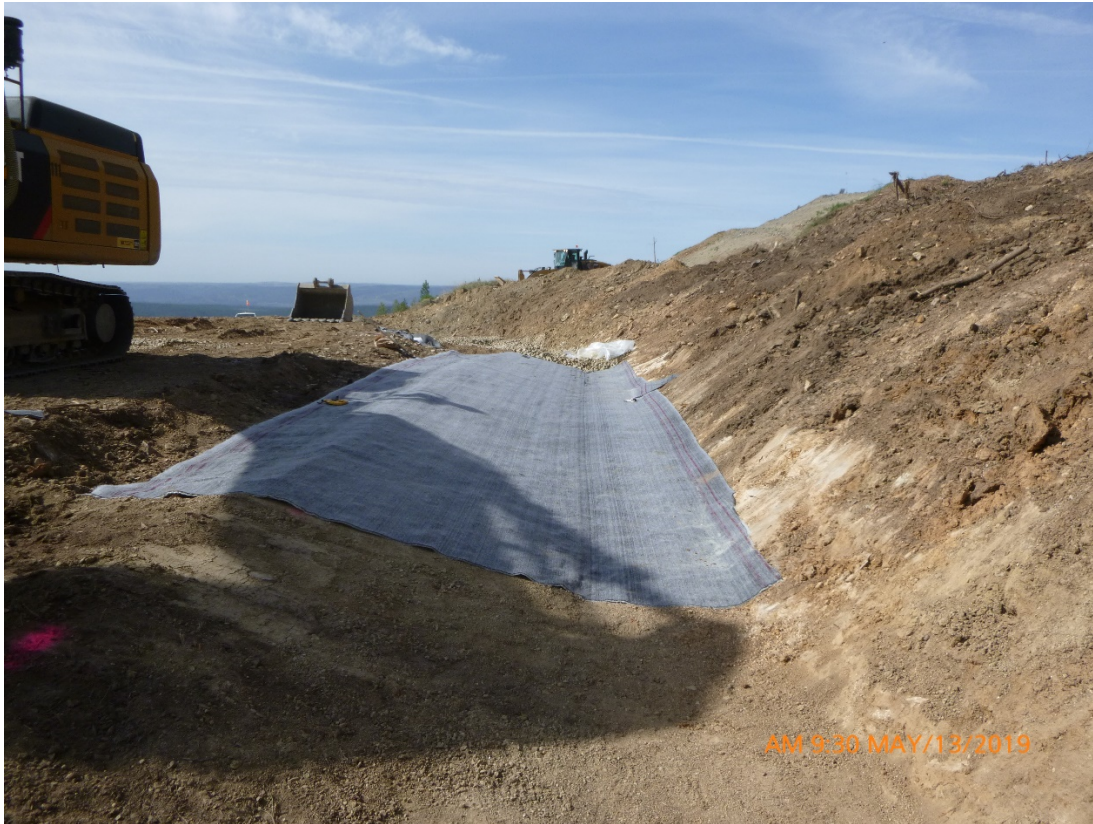
Figure 3 – GCL being placed over prepared subgrade in the west Infiltration Collector

- CQC surveyed the channel subgrade prior to placement of the GCL and drain gravel.
 - GCL placement occurred for the four surveyed sections of the channel and the two corresponding lateral tie-ins.

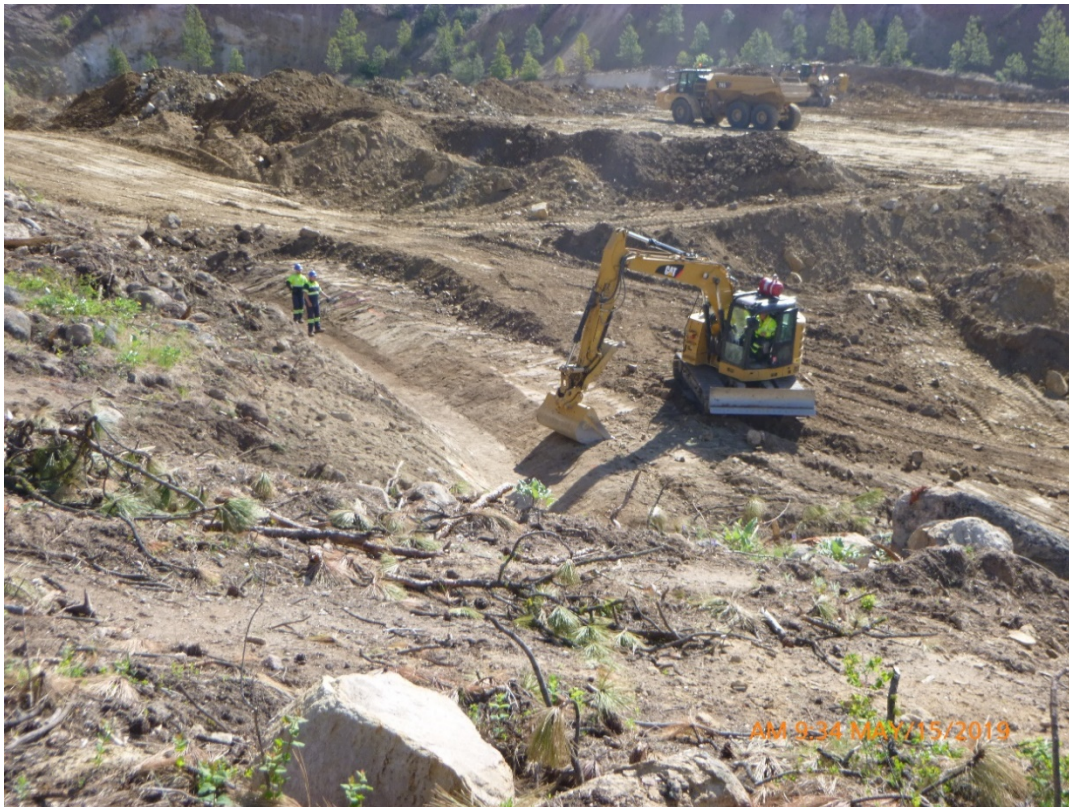
Figure 4 – 315 Excavator preparing subgrade for GCL in the west Infiltration Collector

- West Side Infiltration Collection System (WICS)
 - Excavation continued for the WICS channel located along the west side of Pit 4.
 - The channel subgrade was accepted by CQC-CQA for four sections of the main collector channel and the two corresponding lateral tie-ins.

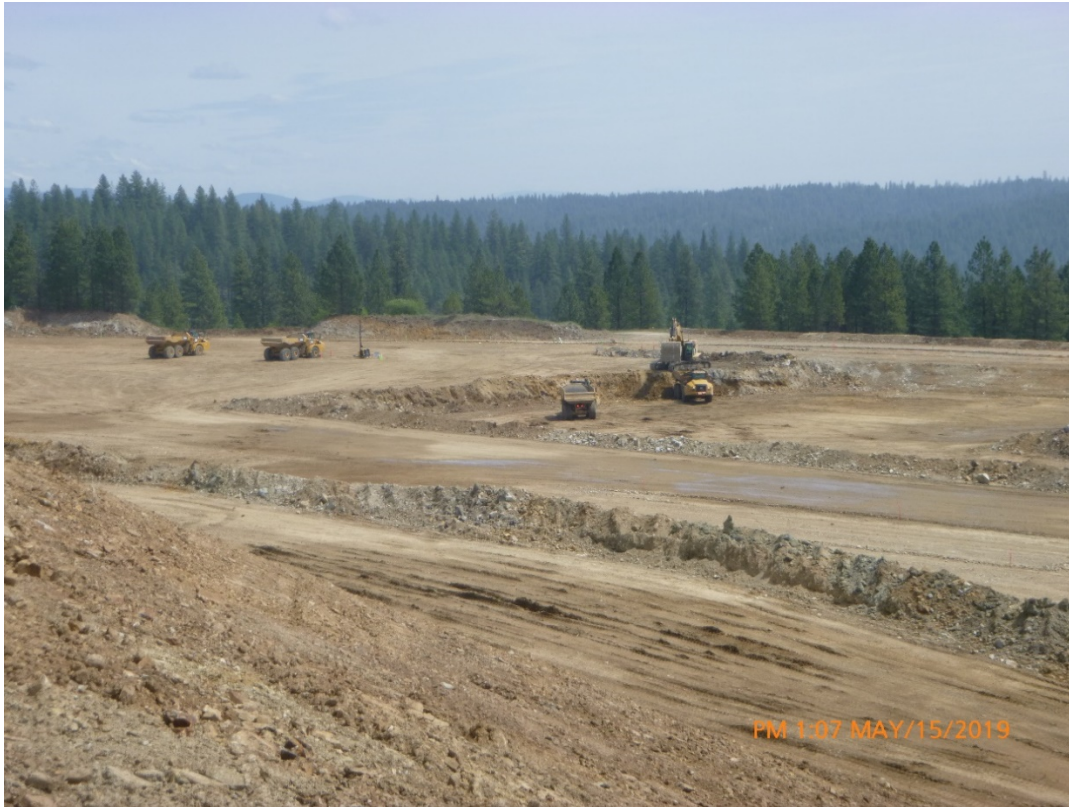
Figure 5 – 390 Excavator loading SWRP material at the South Pond cut

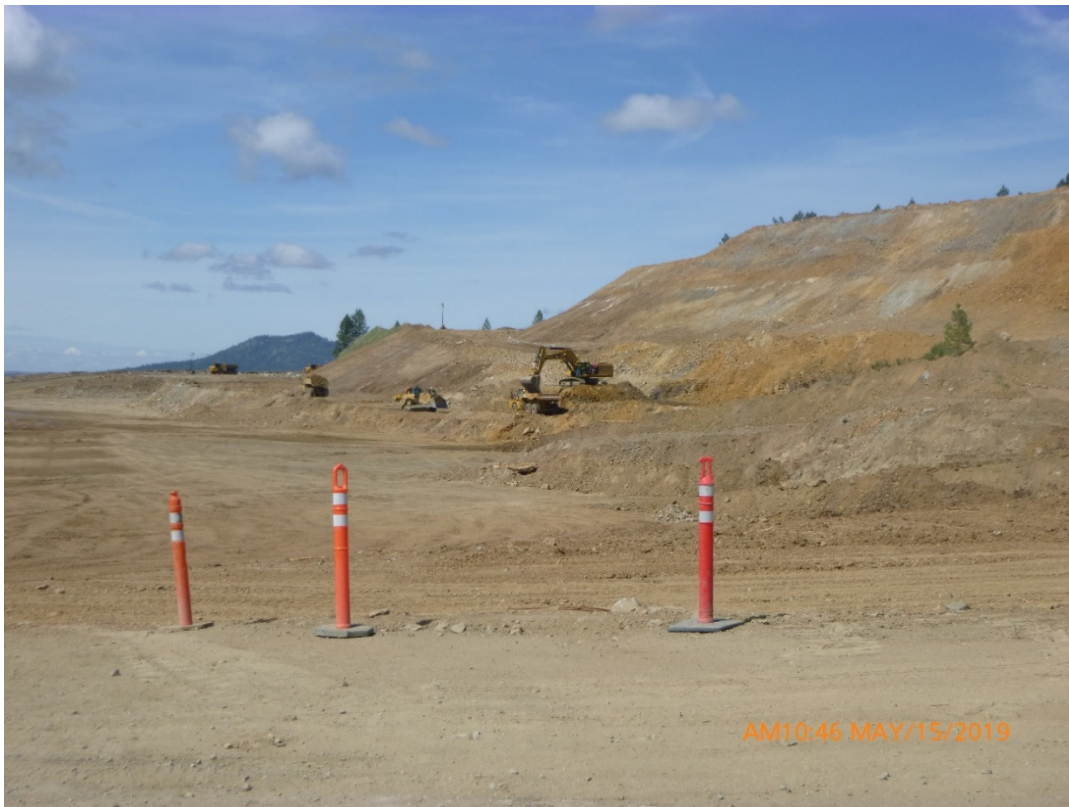
Figure 6 – 390 Excavator loading Stockpile 4 material, D8 dozer assisting with grading

- Pit 4 Backfill
 - Mine waste excavated from Stockpile 8, the North SWRP and the South Pond Cut (all low reactivity material) was placed along the edges of the pit to construct the 20-foot buffer zone (rind). Mine waste excavated from Stockpiles 3 and 4 (high reactivity/high activity material) was placed in areas of the pit bounded by the 20-foot buffer zone.
